DEPARTMENT OF TRANSPORTATION**DIVISION OF ENGINEERING SERVICES**

Quality Assurance and Source Inspection

Contract #: 04-0120F4Cty: SF/ALA Rte: 80 PM: 13.2/13.9File #: 1.28**WELDING INSPECTION REPORT****Resident Engineer:**Pursell, Gary**Address:** 333 Burma Road**City:** Oakland, CA 94607**Report No:** WIR-015958**Date Inspected:** 30-Jul-2010**Project Name:** SAS Superstructure**OSM Arrival Time:** 1000**Prime Contractor:** American Bridge/Fluor Enterprises, a JV**OSM Departure Time:** 1830**Contractor:** American Bridge/Fluor Enterprises, a JV**Location:** Job Site**CWI Name:** See Below**CWI Present:** Yes No**Inspected CWI report:** Yes No N/A**Rod Oven in Use:** Yes No N/A**Electrode to specification:** Yes No N/A**Weld Procedures Followed:** Yes No N/A**Qualified Welders:** Yes No N/A**Verified Joint Fit-up:** Yes No N/A**Approved Drawings:** Yes No N/A**Approved WPS:** Yes No N/A**Delayed / Cancelled:** Yes No N/A**Bridge No:** 34-0006**Component:** Orthotropic Box Girders**Summary of Items Observed:**

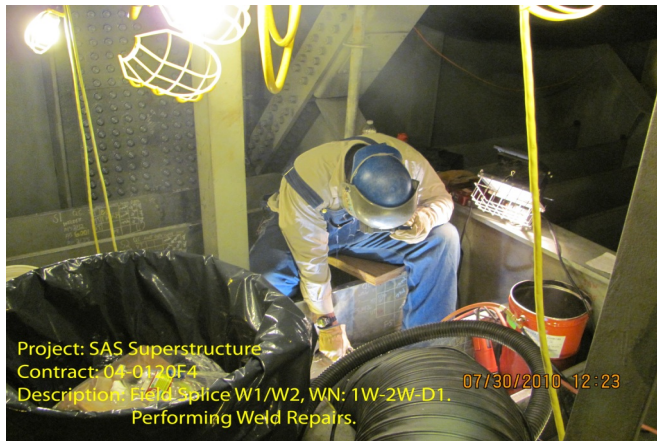
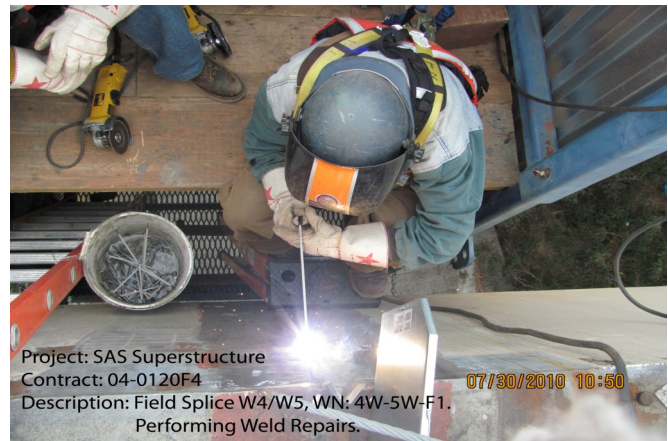
The digital photographs below illustrate the work observed during this scheduled shift.
